October 29, 2020

Andrew Barnsdale  
Project Manager  
California Public Utilities Commission  
505 Van Ness Avenue  
San Francisco, CA 94102

**Re: Monthly Report Summary #35 for the South Orange County Reliability Enhancement (SOCRE) Project**

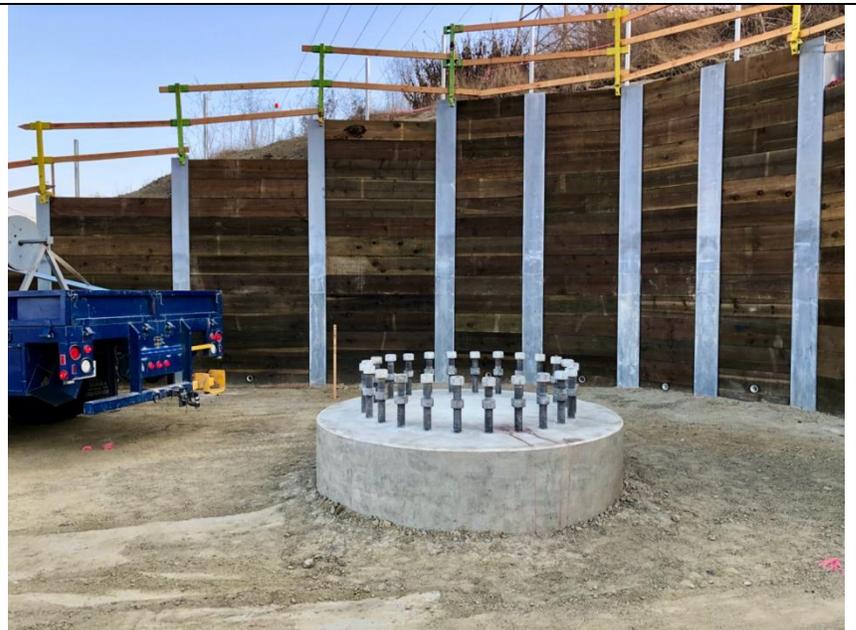
We drove to tower location 24 where a crew had arrived to continue work on the railing on top of the retaining wall. The wall was completed, and the tower foundation had been drilled and poured (Photo 1). The LEI was unsure if a brow ditch was to be installed above the wall at this site. A water truck was watering the access roads for dust suppression.

Photo 1 – New tower foundation and retaining wall at tower location 24. Photo facing north.

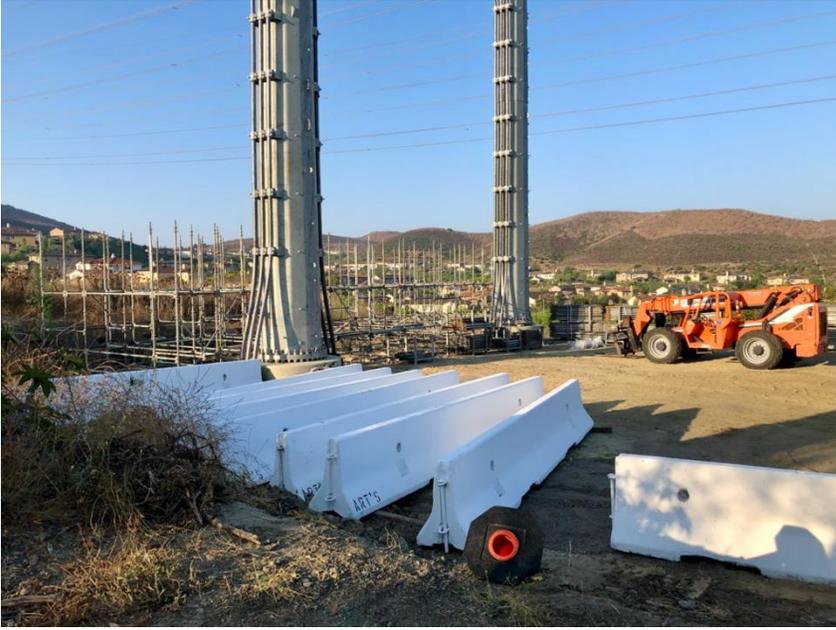
Photo 2 – Scaffolding being erected around towers 18 and 19. Photo facing southwest.
09/04/20	SOCRE transmission corridor

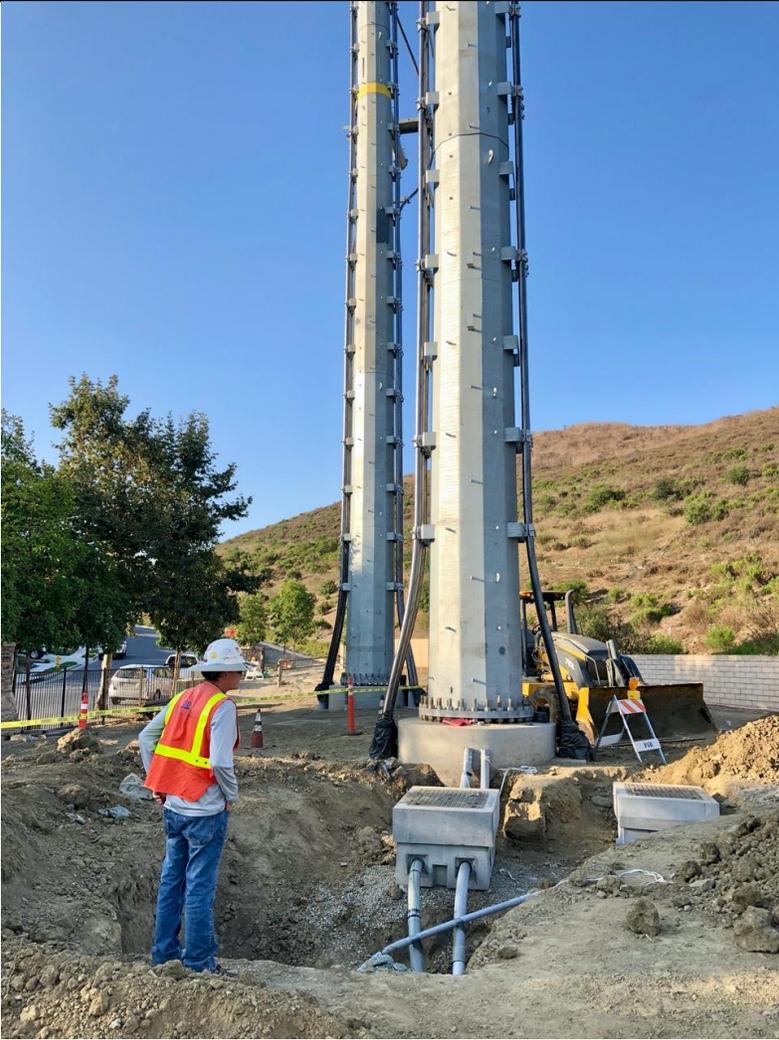
At tower locations 16 and 17, work continued on the vaults near the towers (Photo 3). According to the LEI, the conduit had been installed and was clear of obstructions. Cleanup was required at this location. Sections of sidewalk were damaged by the construction effort and were being replaced along Stallion Ridge Road.

Photo 3 – The final underground vault and conduit work at tower locations 16 and 17 was underway. Photo facing south.

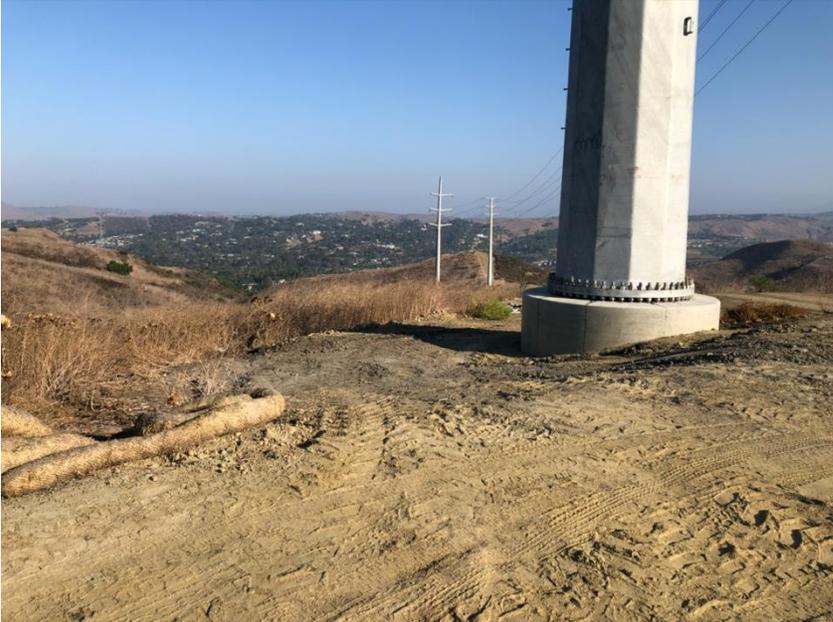
We drove to tower locations 14 and 15 where crews had completed removing the existing tower foundations to 2 feet below grade (Photo 4). At both locations, the areas had been remediated and the materials from the existing foundations had been removed.

Photo 4 – Tower location 15 where the existing foundation had been removed. Tower location 14 can be seen in the background. Photo facing north.
09/04/20	SOCRE transmission corridor

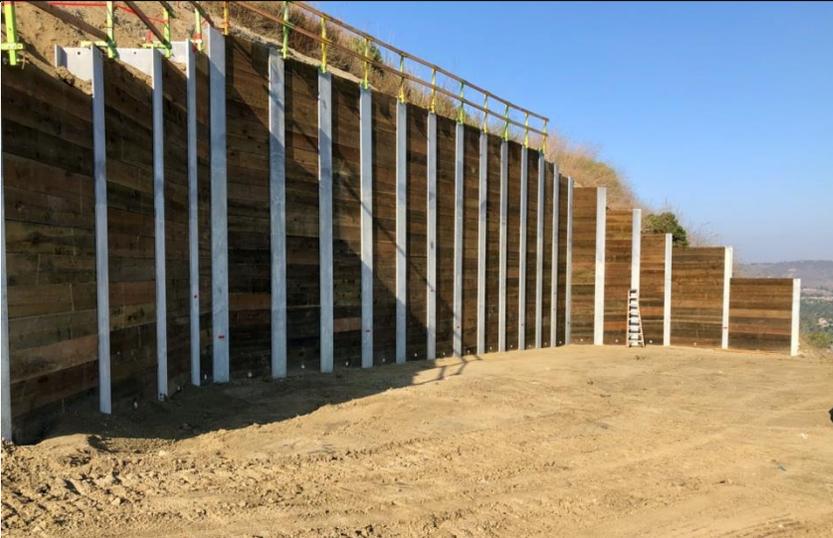
We followed the access road to tower location 13 where the wall and the pad had been built (Photo 5). Work was scheduled to begin drilling the foundation hole, but no equipment was present onsite; the work may be delayed due to the upcoming three-day weekend. The wall required a permanent railing and a brow ditch to be poured above the wall.

Photo 5 – The retaining wall at tower location 13. Photo facing northwest.

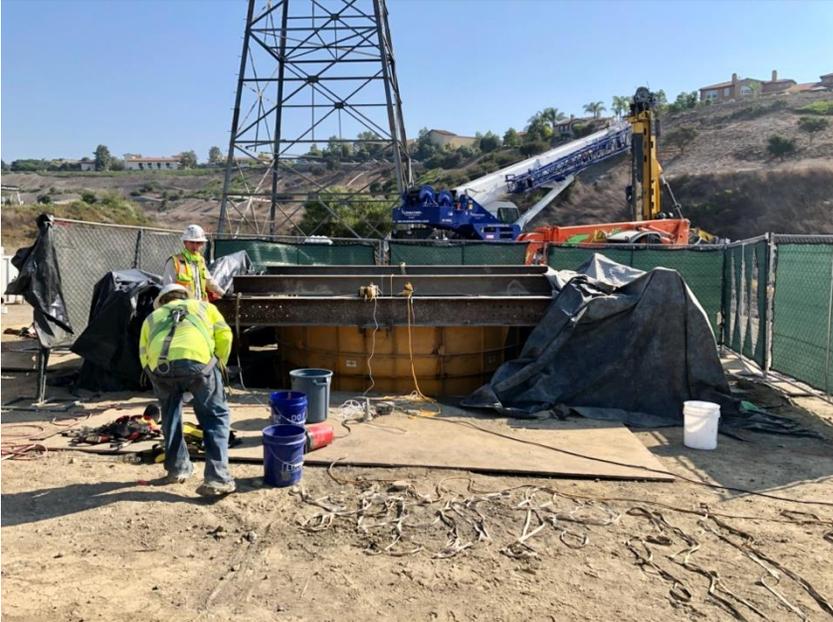
Photo 6 – Foundation work continuing at tower location 34. Photo facing south.
09/04/20	SOCRE transmission corridor

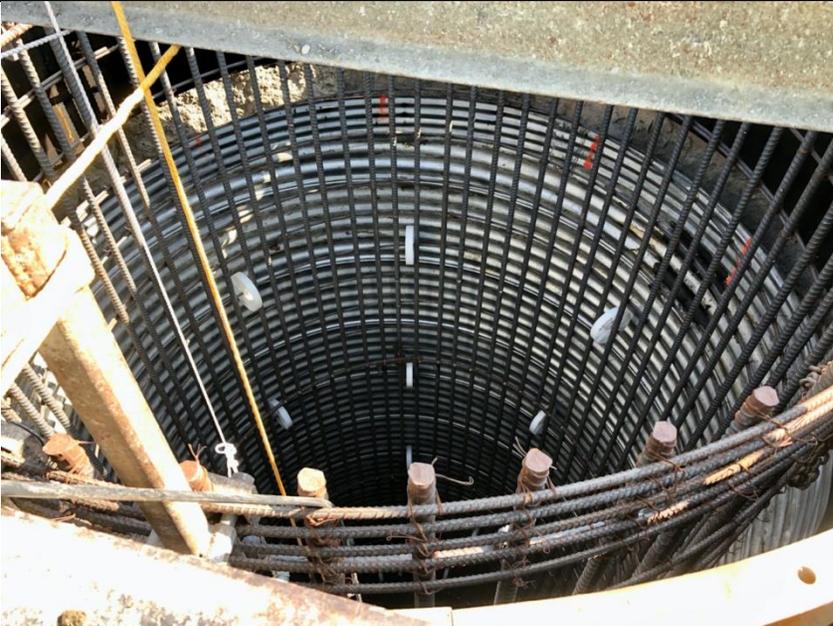
At tower location 34, work continued on the tower foundation (Photo 6). The rebar cage was set and water needed to be pumped out from the bottom of the hole (Photo 7). Crews planned to pour the foundation early the following week and would seal the hole with plastic and fencing for the upcoming three-day weekend. At this location, a new Environmental Inspector (EI) was onsite. I introduced myself and discussed my role and some of the conditions of the project.

Photo 7 – The rebar cage placed in the foundation hole at location 34; concrete pouring was expected to occur the following week.

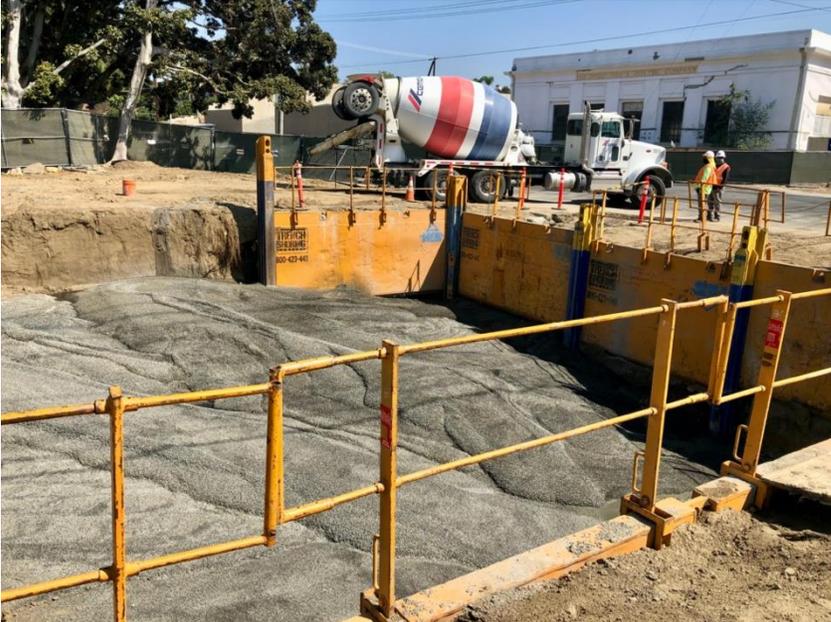
Photo 8 – The bore pit was filled with slurry. Photo facing northeast.
09/04/20	West of San Juan Capistrano Substation-jack and bore site

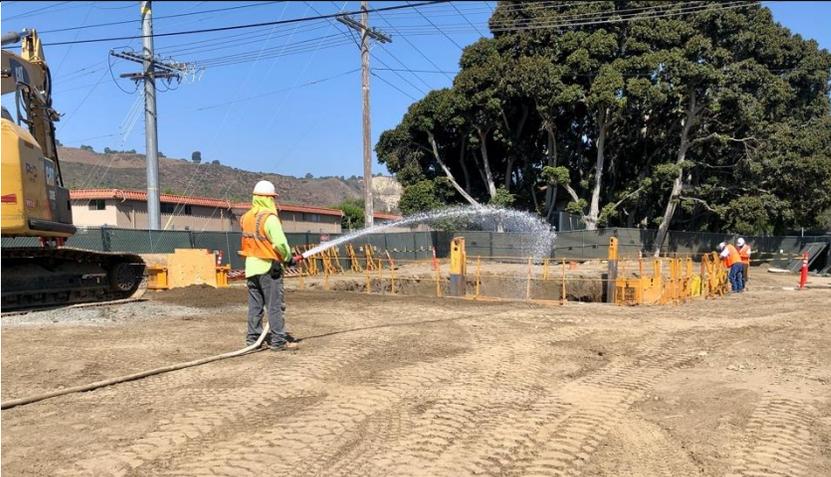
Photo 9 – Dust control being performed around the bore pit. Photo facing north.

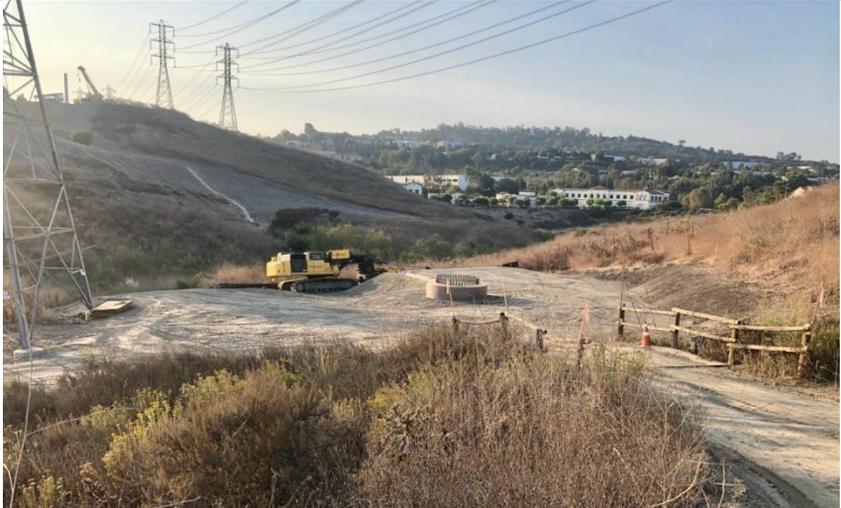
My first stop was at tower location 34 where the foundation was completed and crews were cleaning up the site (Photo 1). I observed several small mammal tracks in the dusty soil around the new foundation and asked that the area receive extra watering to reduce dust over the weekend. One drill rig remained onsite and I noted hydraulic fluid leaking into the new concrete-lined drainage channel (Photo 2). Fluid had leaked down into the rock energy dissipater that was lined with filter fabric. The leak did not appear to go beyond the energy dissipater and into the creek channel. The LEI called the KV Structures team, which arrived onsite to clean up the fluid. Absorbent pads were placed and the LEI said they would dig out the contaminated soil and place kitty litter on the concrete.

Photo 1 – Tower location 34 where foundation pouring was completed. Photo facing south.

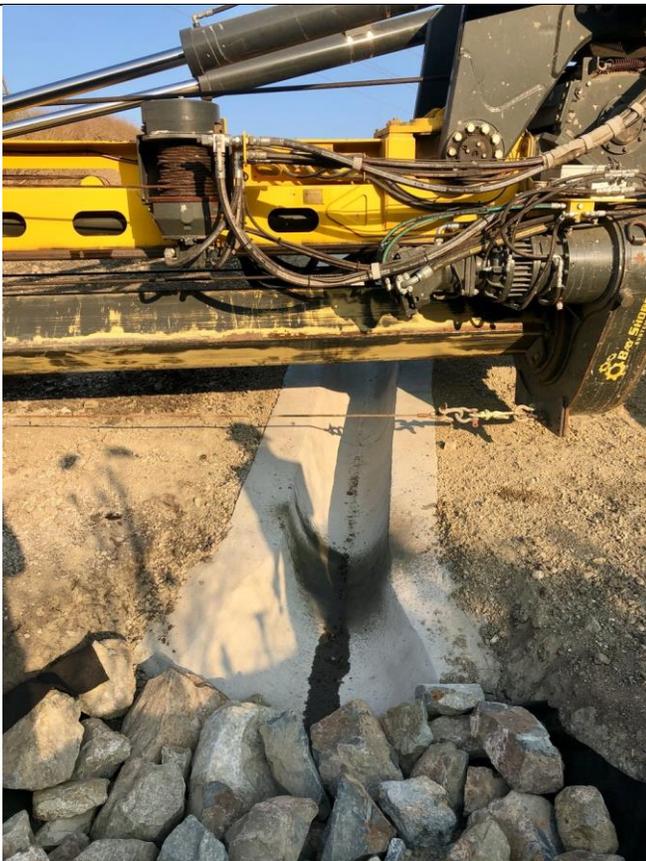
Photo 2 – Hydraulic fluid leak from the drill rig at tower location 34. Photo facing north.
09/18/20	SOCRE transmission corridor

Equipment should not be parked over drainage areas to avoid impacts of fluid leaks.

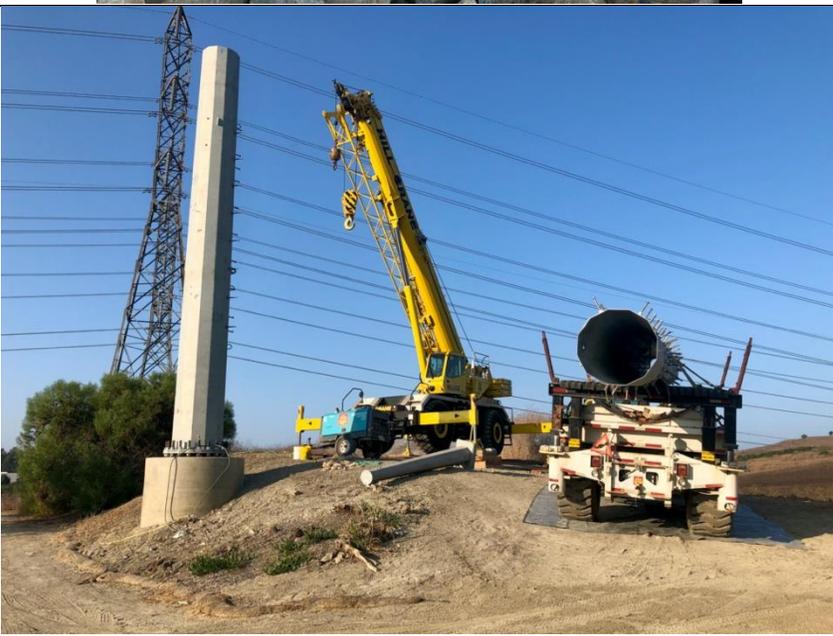
Photo 3 – The tubular steel pole installation at tower location 35. Note the tarp under the old, leaky equipment. Photo facing west.

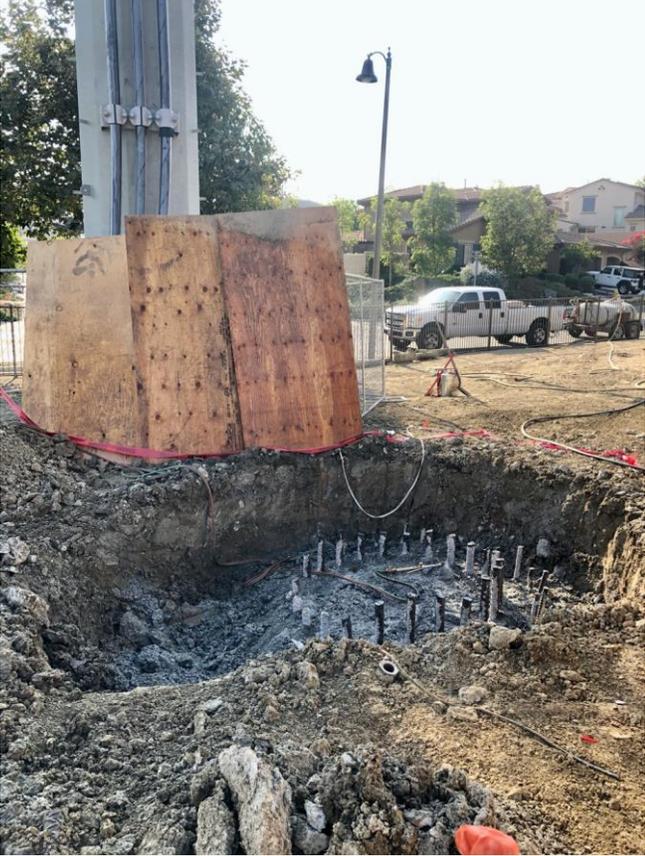
At tower locations 16 and 17, a crew was removing the existing tower foundations to a depth of 2 feet below grade (Photo 7). The existing rebar needed to be removed and required a hot work permit. Scaffolding was being installed and the LEI described the proposed locations of the K rail anchors. The plan was to place them outside of the wall and over the drainage channel (Photo 8). The K rails would be placed with a crane and no vegetation would be damaged.

Photo 7 – Tower locations 16 and 17 where existing foundation removal was underway to 2 feet below grade. Photo facing south.

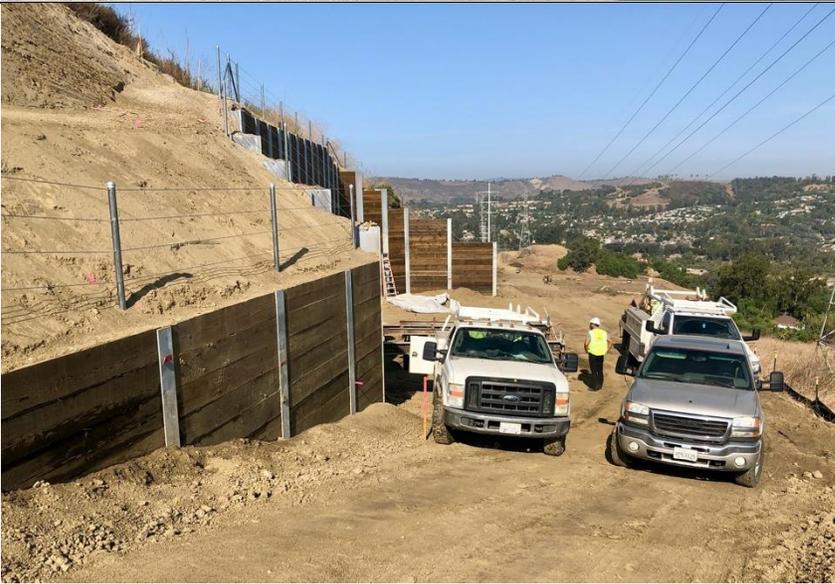
The majority of the wall and pad work had been completed at tower location 13 (Photo 11) and the foundation was being poured (Photo 12).

Photo 11 – Tower location 13 where retaining wall and pad work were completed. Photo facing north.
09/18/20	SOCRE transmission corridor

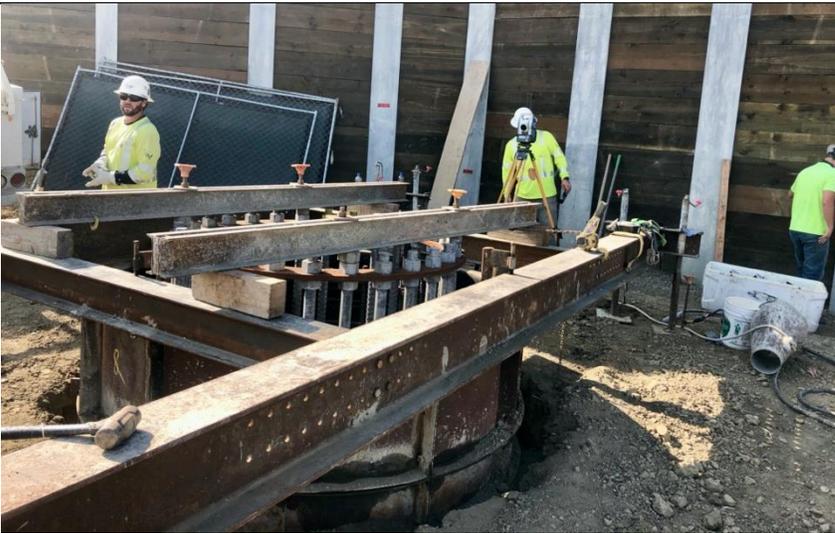
Photo 12 – Foundation hole and cage at tower location 13 ready for concrete pouring. Photo facing west.

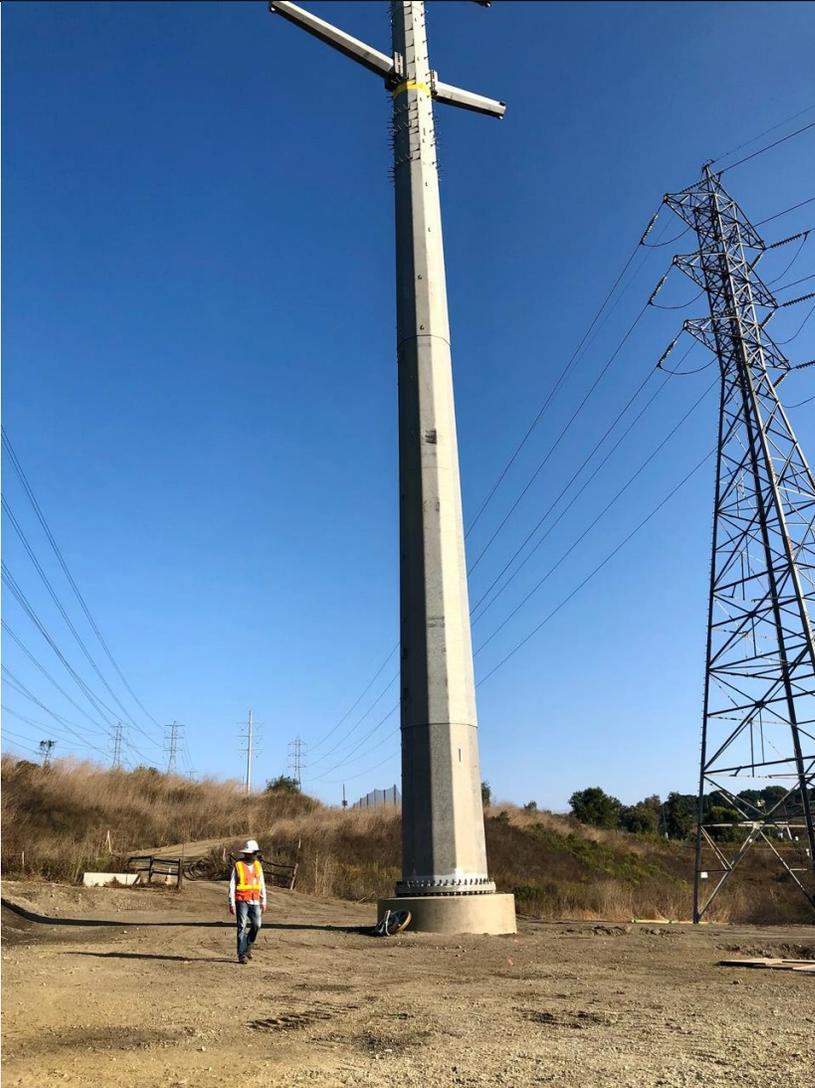
We drove to tower location 34 where the tubular steel pole (TSP) installation was completed (Photo 2). The leaky drill rig remained onsite, but was moved away from the drainage area with secondary containment in place (Photo 3). According to the EI the equipment was scheduled to be relocated soon.

Photo 2 – Newly installed TSP at tower location 34. Photo facing northeast.

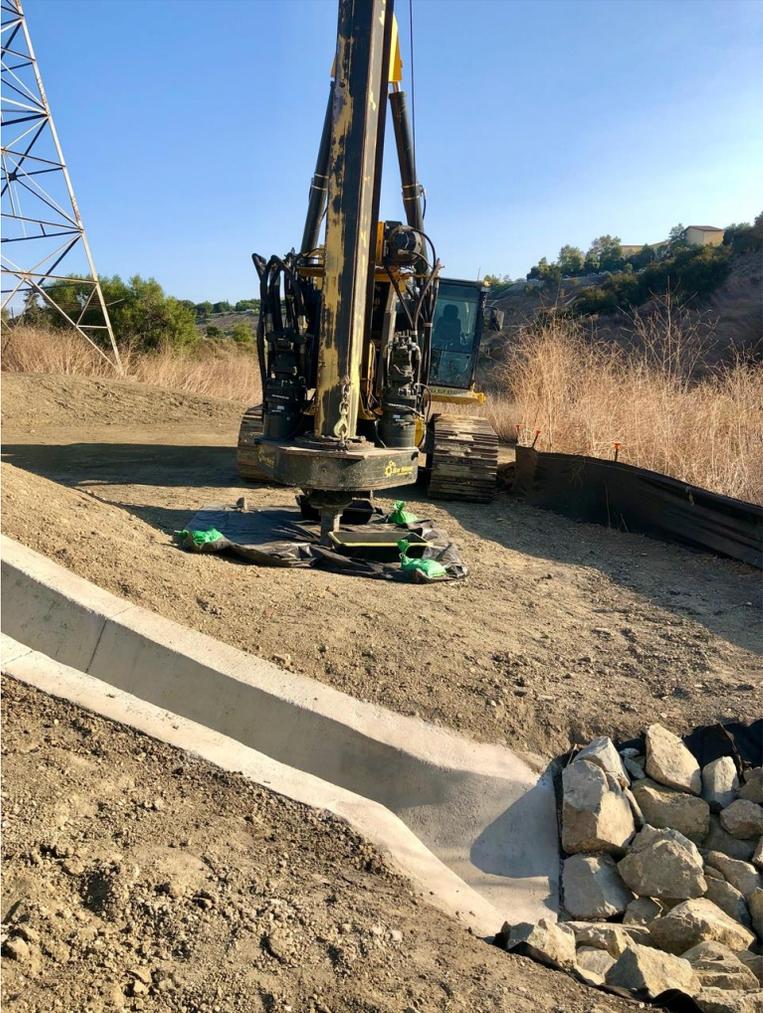
Photo 3 – The leaky drilling equipment at tower location 34 was moved and stabilized. Photo facing east.
09/24/20	SOCRE transmission corridor

Parking equipment over any drainage locations should be avoided in case of fluid leakage.

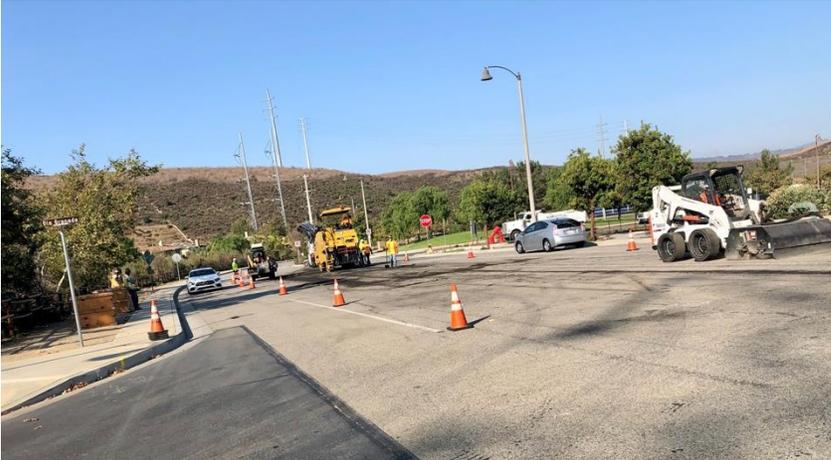
At Stallion Ridge Road, a paving crew had started repaving of the roadway (Photo 5). Crews had also replaced portions of the sidewalks and were restoring the conduit corridors (Photo 6).

Photo 5 – Paving work along Stallion Ridge Road. Photo facing west.
09/24/20	SOCRE transmission corridor

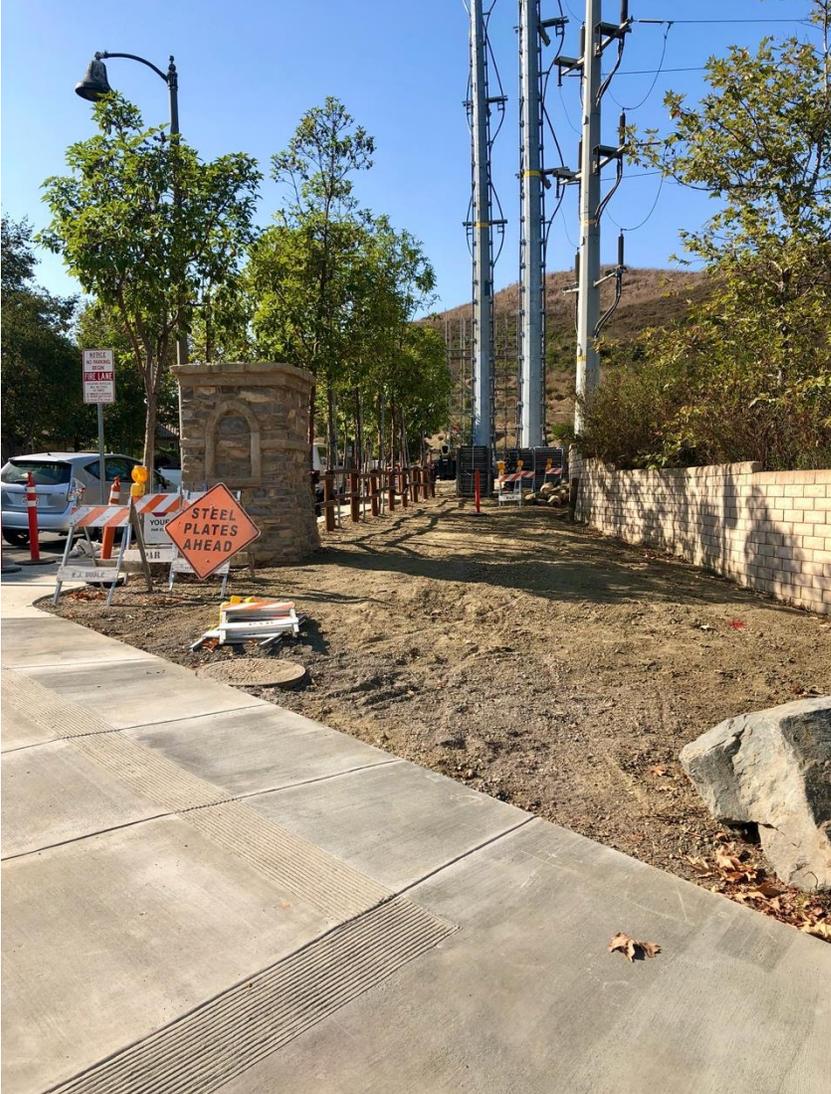
Photo 6 – Restoration of the conduit trench, including sidewalk repair near towers 16 and 17. Photo facing southwest.

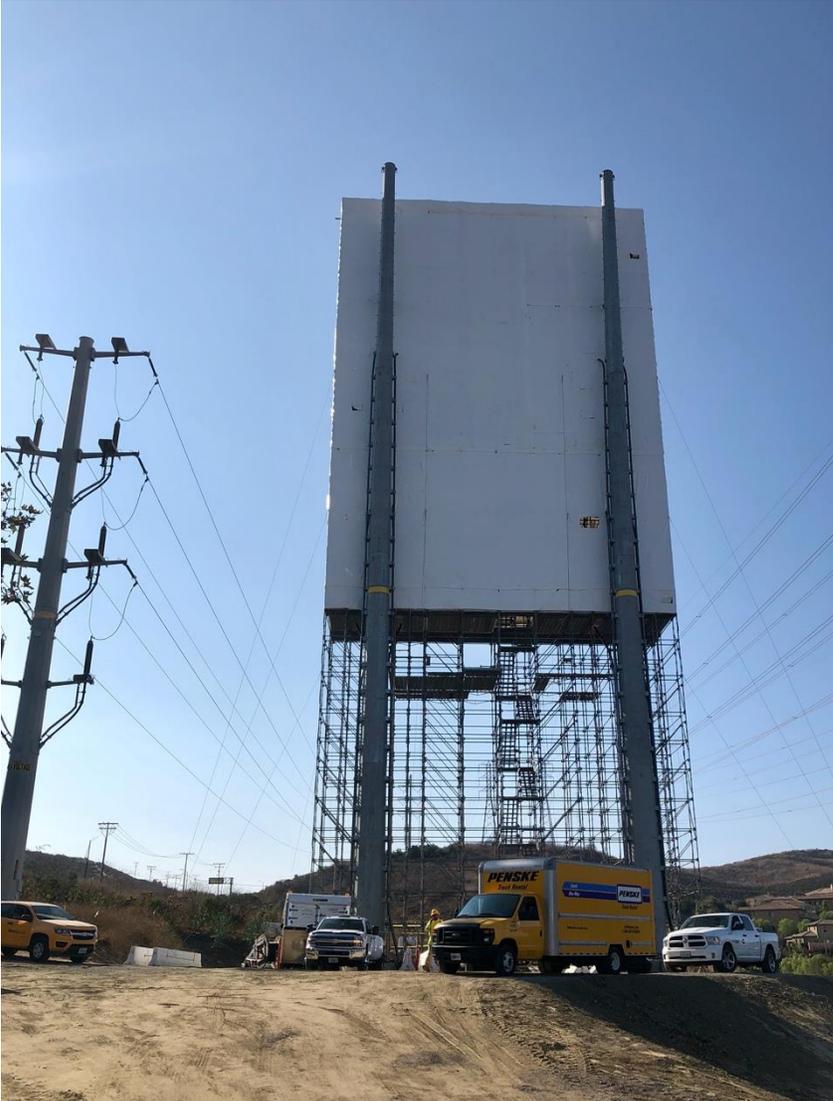
At tower locations 18 and 19, the scaffolding was installed and wrapped in plastic (Photo 7). The avian biologist was onsite and observed a great horned owl (*Bubo virginianus*) roosting inside of the plastic wrapped scaffolding. He climbed up to check on the bird, which seemed fine. Several holes were cut in the plastic at the top of the scaffolding and the bird flew out.

Photo 7 – Plastic-wrapped scaffolding at tower locations 18 and 19. Photo facing south.

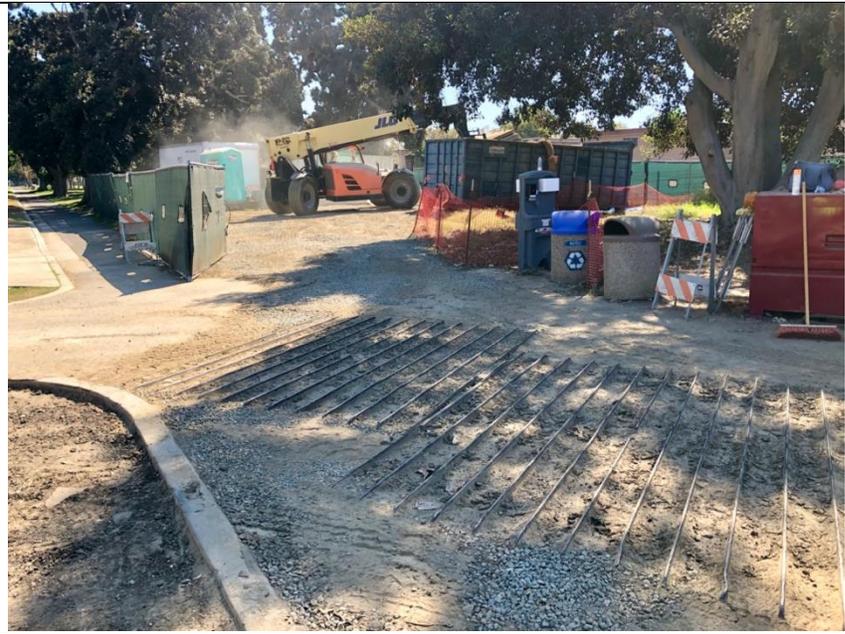
Photo 1 – Jack and bore staging area where exit and entry BMPs required maintenance. Photo facing southwest.
09/29/20	West of San Juan Capistrano Substation-jack and bore site
